Analysis of Lighting Fixtures

MMR Project No. 82999

MassDOT
Boston, MA

April 5, 2011

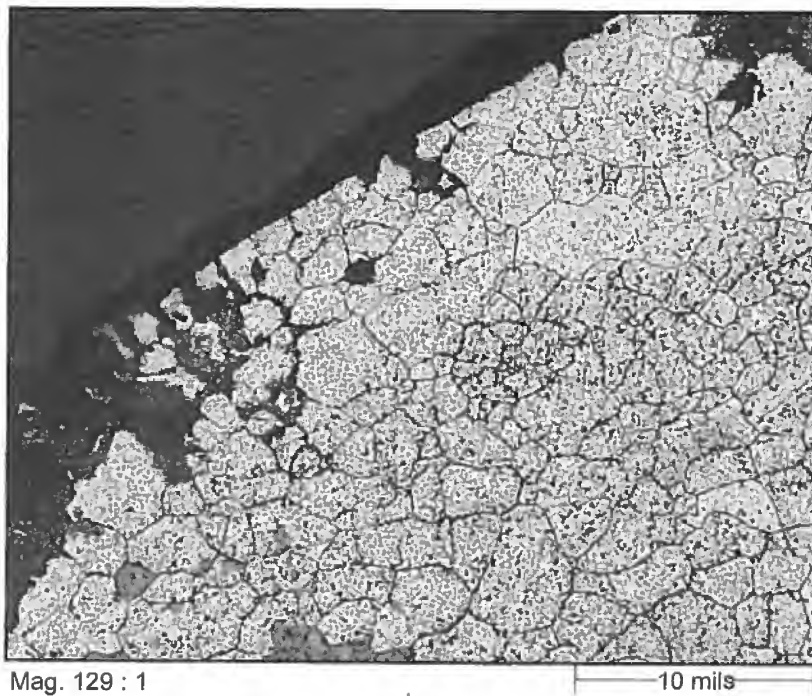
Figure 43: Sample #1: Mount 1-2; note significant corrosion on the lip. Etched.

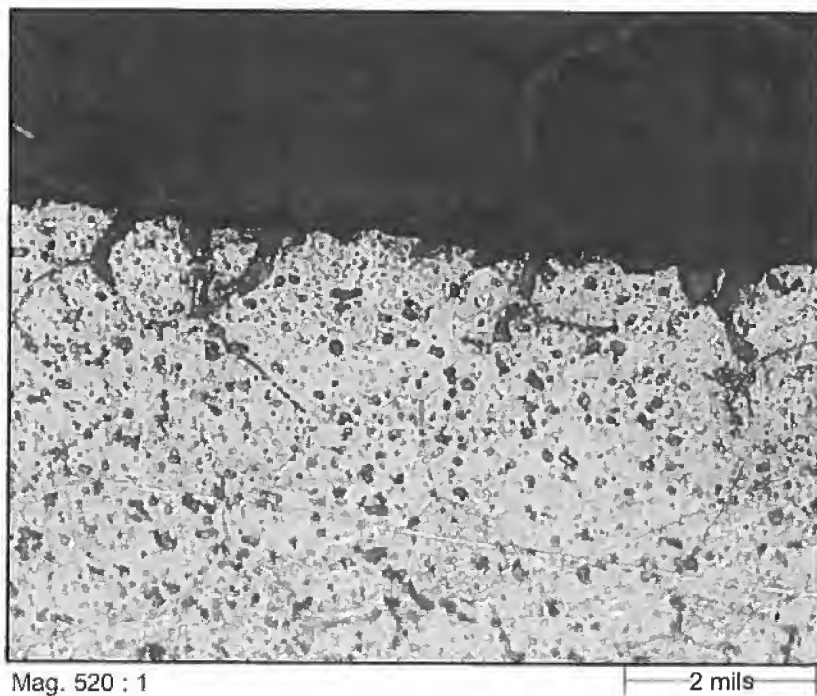
Figure 45: Sample #1: Mount 1-2; corrosion initiation in intergranular mode on lip radius . Etched:

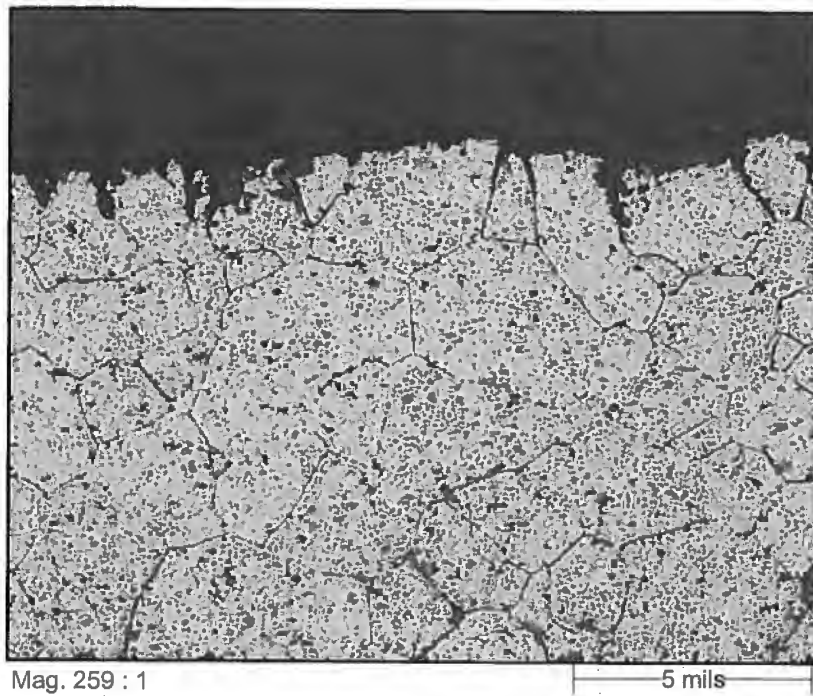
Figure 46: Sample #1: Mount 1-2; corrosion initiation on another surface. Etched.

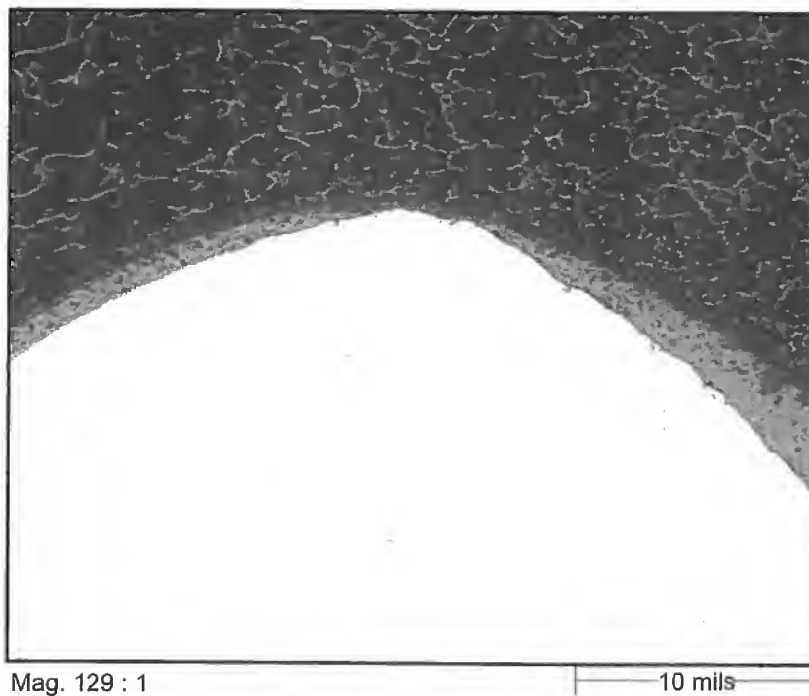
Figure 47: Sample #2: Mount 2-1; lip edge corner showing the thinner coating. Unetched.

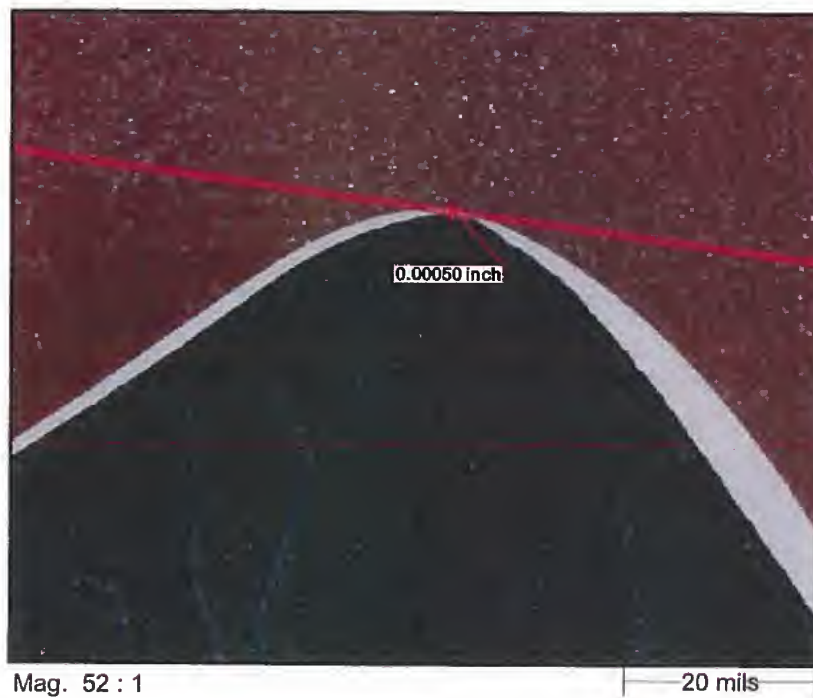
Figure 60: Sample #2: NuArt, new. Mount 2-2. A corner of the lip showed the coating thickness to be 0.0005".

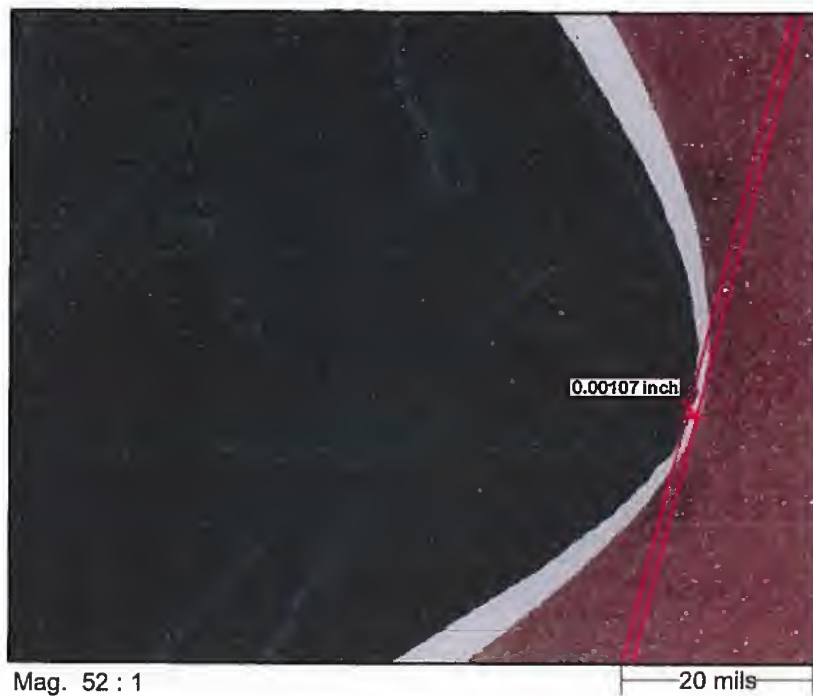
Figure 61: Sample #2: NuArt, new. Mount 2-2. The other corner of the lip showed the coating thickness to be 0.001".

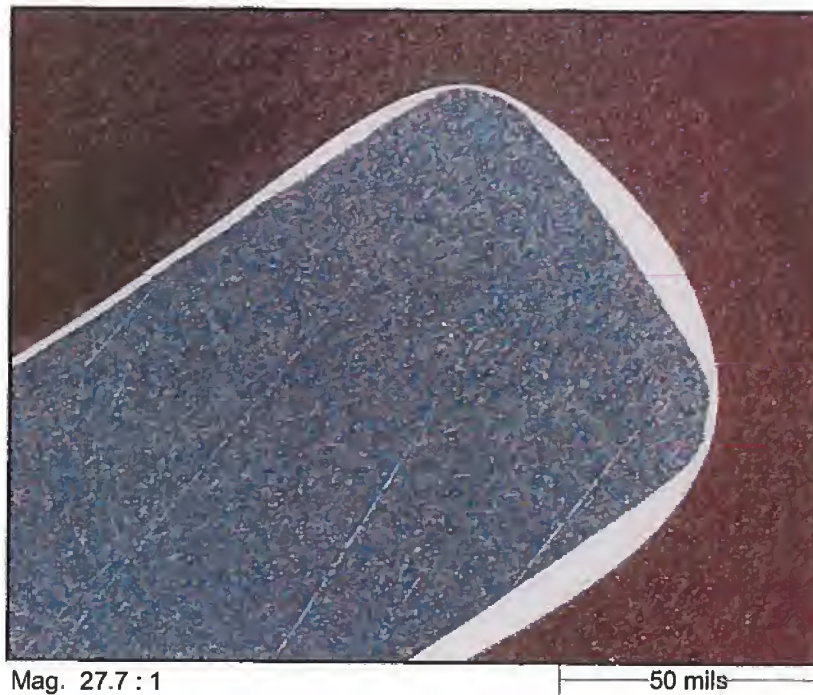
Figure 64: Sample #3: Schreader, new. Mount 3-2. A higher magnification view of the lip area. Note thin coating at the edges/corners.

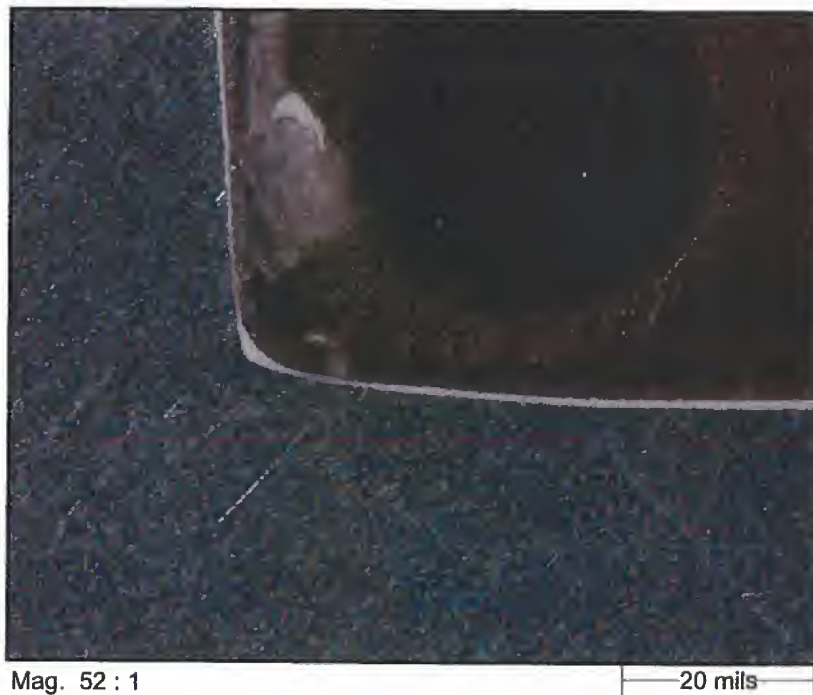
Figure 68: Sample #3: Schreader, new. Mount 3-2. Note the variation in coating thickness. This is the radius at the lip.

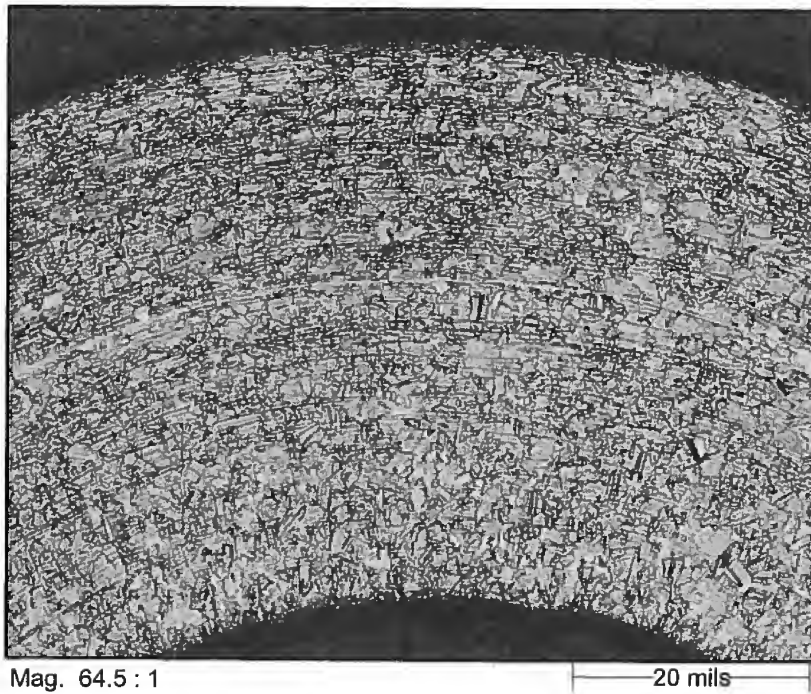
Figure 69: Failed clip: No corrosion noted at the ID of the bend. Etched.

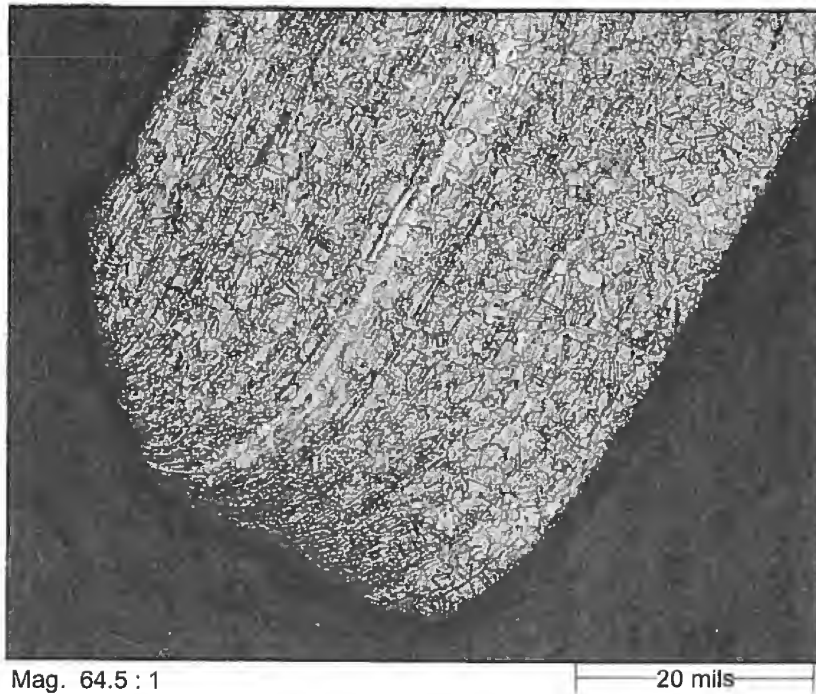
Figure 70: Failed clip: No corrosion noted at the wireway contact corner. Etched.

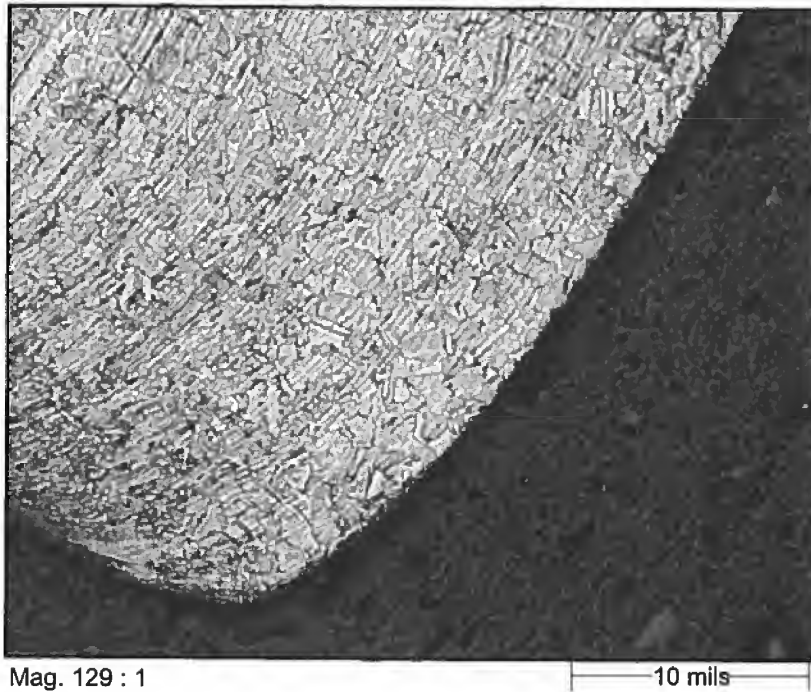
Figure 71: Failed clip: No corrosion noted at the wireway contact corner. A higher magnification view. Etched.

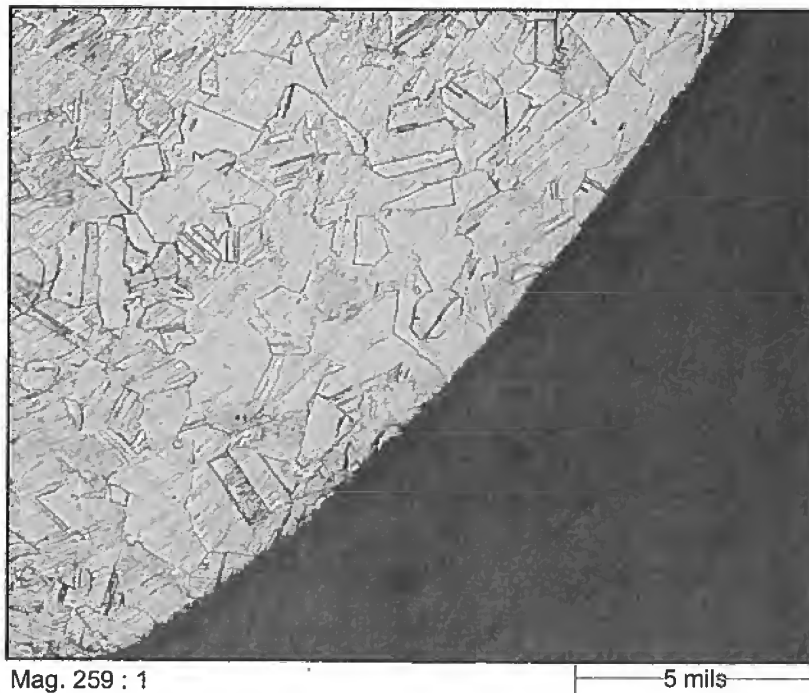
Figure 72: Failed clip: No corrosion noted at the wireway contact corner. A higher magnification view. Etched.

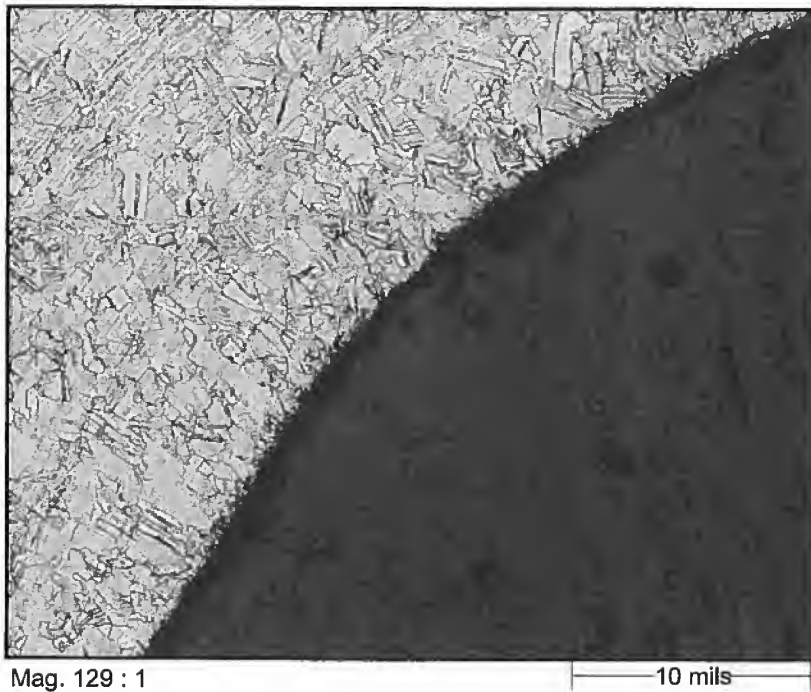
Figure 73: Failed clip: No corrosion noted at the ID of the bend. This area would be in contact with the wireway. Etched.

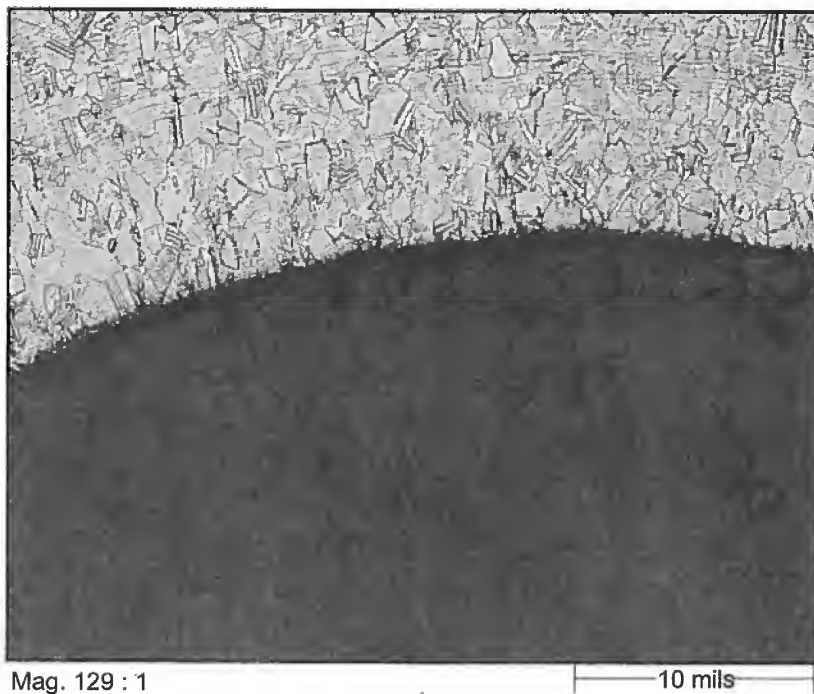
Figure 74: Failed clip: No corrosion noted at the ID of the bend. This area would be in contact with the wireway. A higher magnification view. Etched.

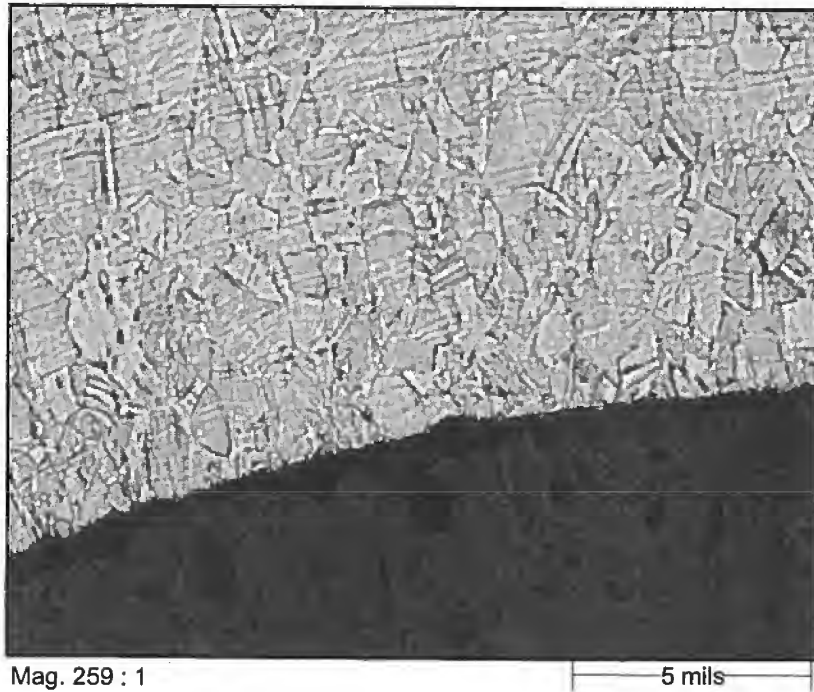
Figure 75: Failed clip: No corrosion noted at the ID of the bend. This area would be in contact with the wireway. A higher magnification view. Etched.

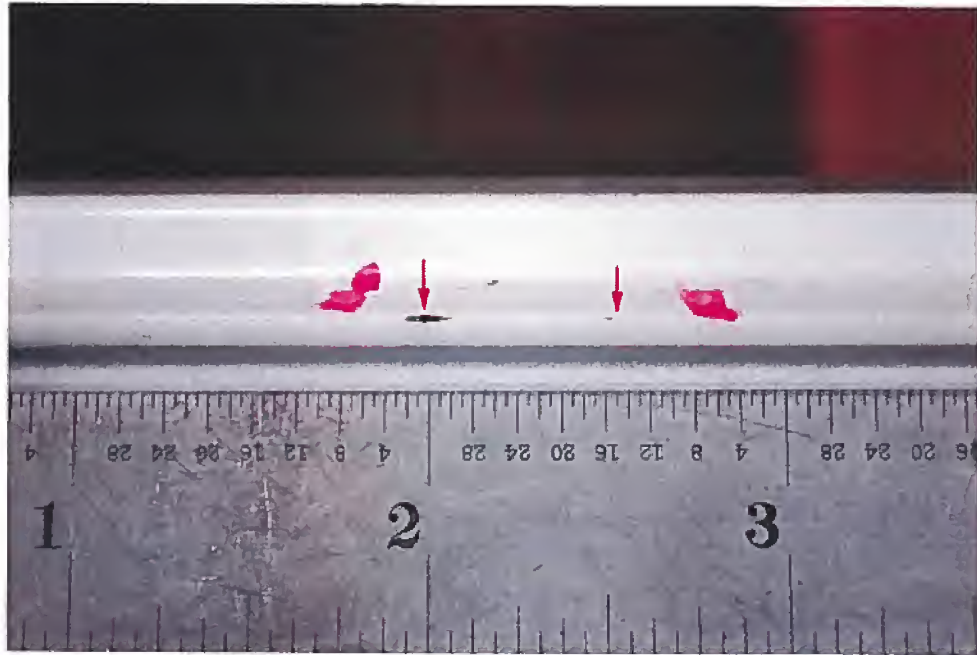
The new light fixture was assembled to the new wireway pieces, sample #2 (NuArt) and sample #3 (Schreader). The clips were attached with extreme care. It was noted that for both samples, the coating was abraded at the lip edge locations; the damage was greater for the NuArt sample than compared to the Schreader. Effort was needed to assemble the wireway to the light on the NuArt sample. The Schreader wireway assembled easily.

Figure 82: Sample #2 (NuArt): The wireway lip area after removal of the clip. Arrows point to the breached coating at the edge/corner. The coating was intact in this location before assembly of the clip.

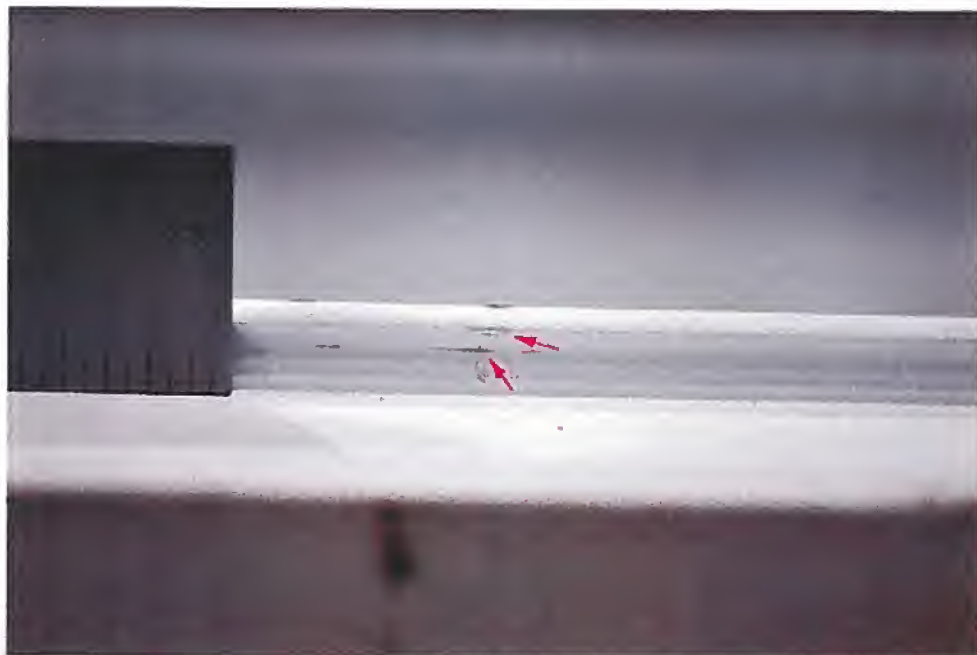
Figure 83: Sample #2 (NuArt): The same area as in the previous photograph showing the coating damage, arrows, on the underside of the lip after removal of the clip.

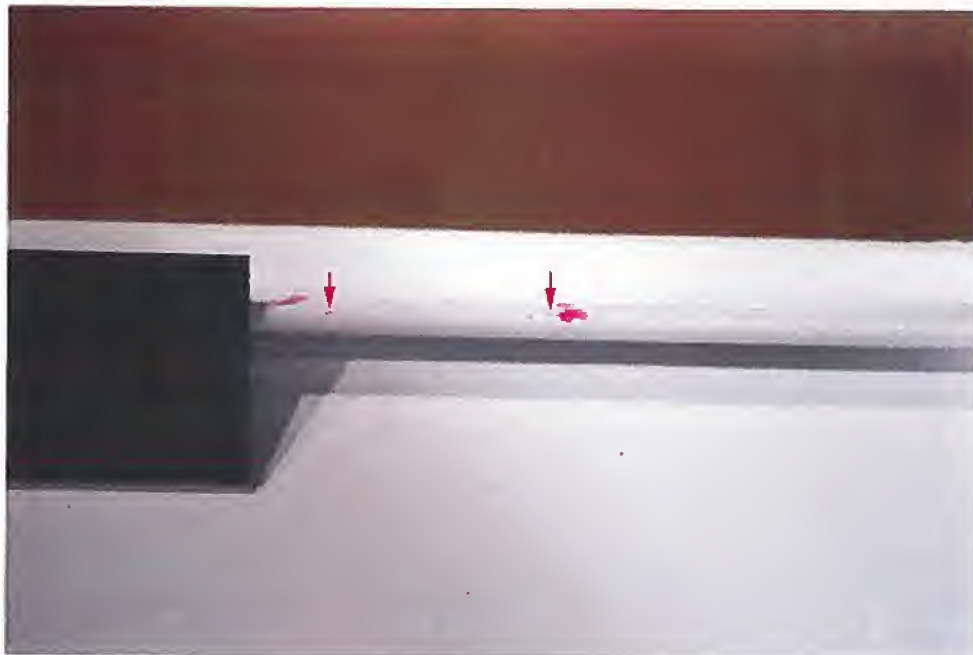
Figure 87: Sample #3 (Schreader): The same area as in the previous photograph after removal of the clip. The arrows point to the damaged coating at the lip edge.

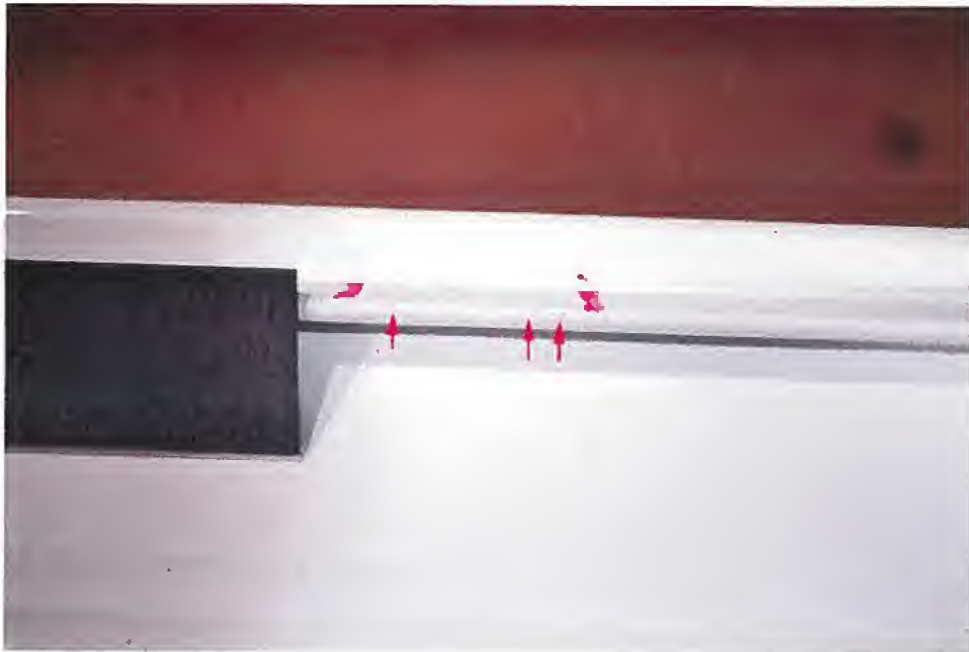
Figure 88: Sample #3 (Schreader): Another view of the area in Figure 87. Arrows point to coating damage.
